Confidential Inspection Report

LOCATED AT:
194 Pleasant Avenue
Bellview Heights, New Jersey 07101-2345

INSPECTED ON:
Wednesday, February 13, 2019

Inspector, John J. Hayes NJ 24GI 00172500
ClearView Home Inspections, L.L.C.

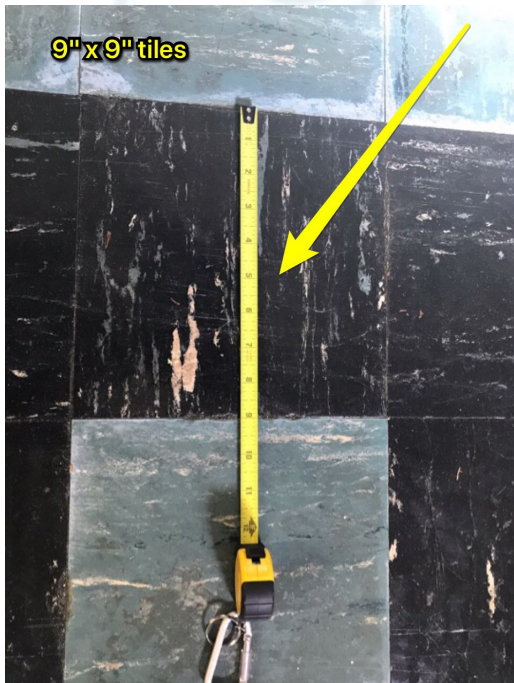
Basement FLOOR

ATTN 1: The tile floor covering, where visible in portions of the basement, is a type that frequently contains asbestos. Actual asbestos content can only be determined by laboratory testing. Further information on asbestos can be obtained from a licensed asbestos consultant or abatement contractor.

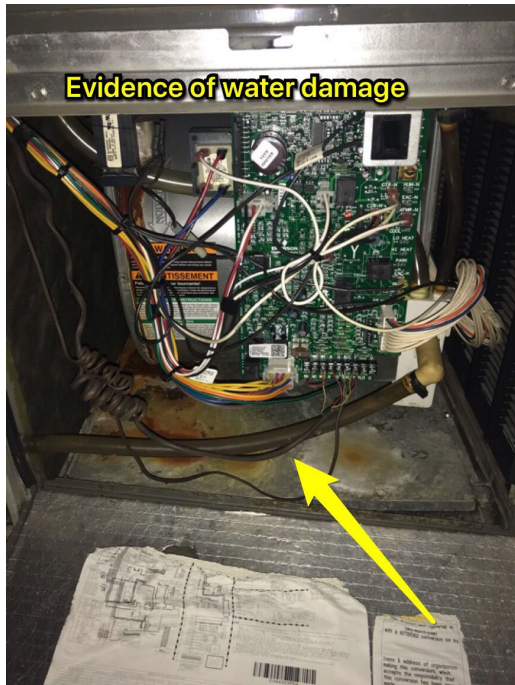
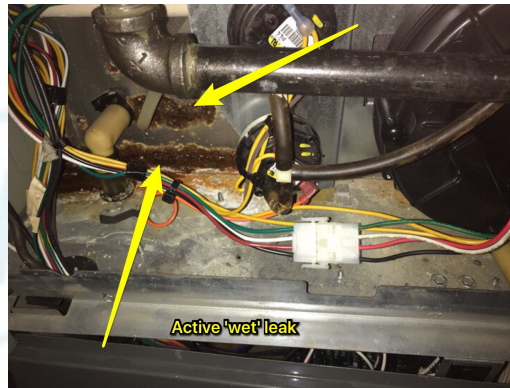
OK **URG** **2:** The two heating systems in the house both responded to normal operating controls. Components appear properly installed and are currently serviceable. Routine maintenance will keep them functional and maximize their service life. NOTE: The Trane XV90 model furnace showed signs of active water penetration. This should be further investigated by a professional HVAC technician.

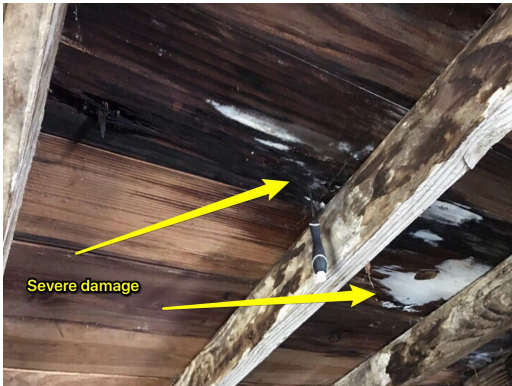
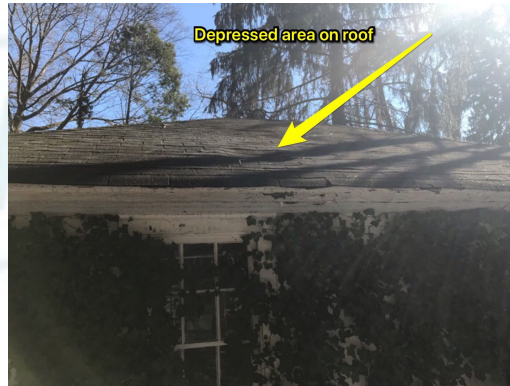
Detached Garage roof underside

NOTE: There is a second, detached garage on the property. The roof on this garage is seriously compromised, and must be replaced, including the under-sheathing and potentially any damaged structural support below. Additionally, there is a significant depression in the roof surface. We recommend repair or replacement by a NJ Licensed roofing contractor.

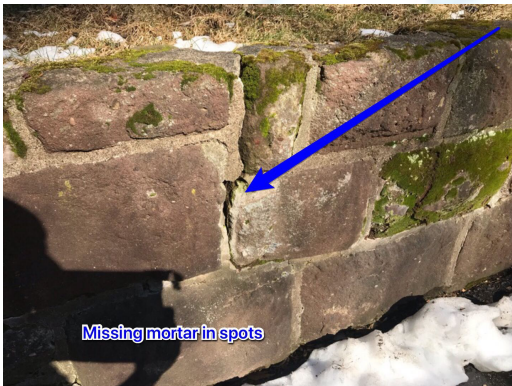
OK **FYI** Retaining wall material: The retaining wall near the driveway is made of brownstone, and is in need of general maintenance of the mortar. The retaining wall below the pool area is made of concrete, and appears to be in good shape.

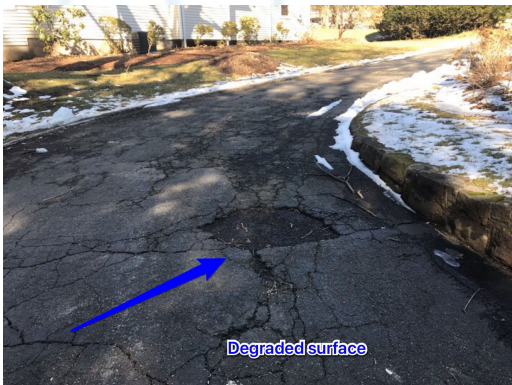
Driveway: Asphalt. The driveway is in need of maintenance in spots. Large cracks, surface degradation and a small sink-hole should be tended to.

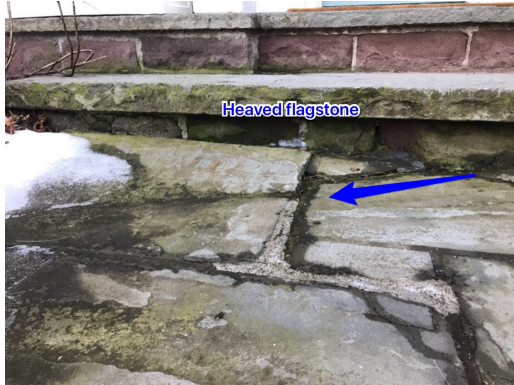
Walk at Front Steps

Walkways: Stone set in mortar. While part of the main walkway was covered with snow, certain visible areas showed a need for general maintenance - missing stone, cracked/missing mortar, etc.

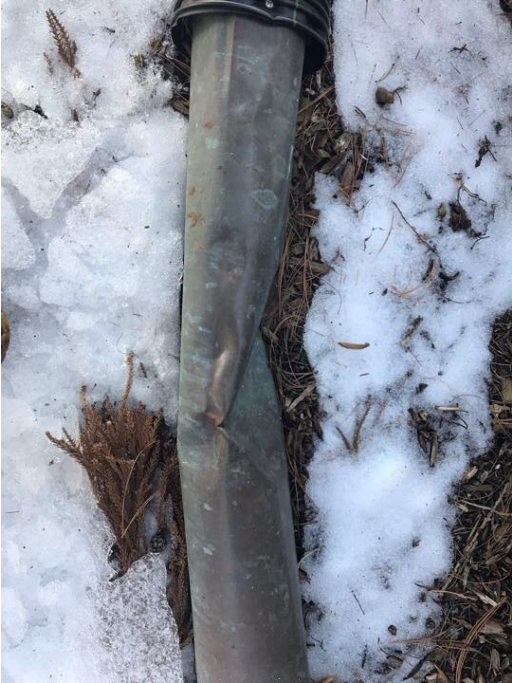
NOTE: There is a crushed downspout which should be fixed.

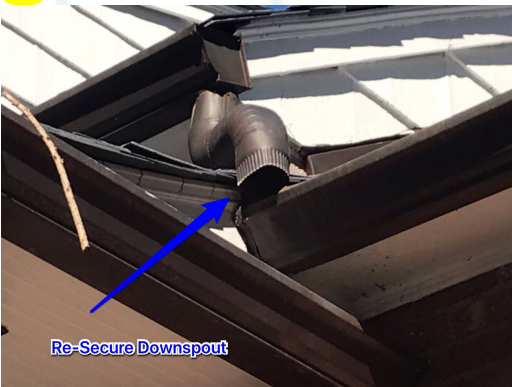
ATTN One or more of the downspouts are loose and should be re-secured during regular maintenance.

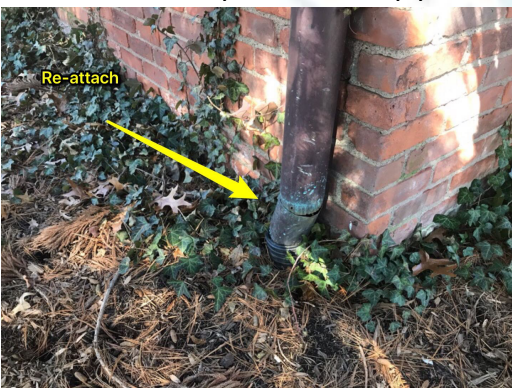
ATTN One or more downspouts empty water into underground drainage pipes. These underground drainage pipes must be kept free of leaves and debris. Proper drainage should be monitored during periods of heavy rain and, if backup occurs, the pipes must be cleared.

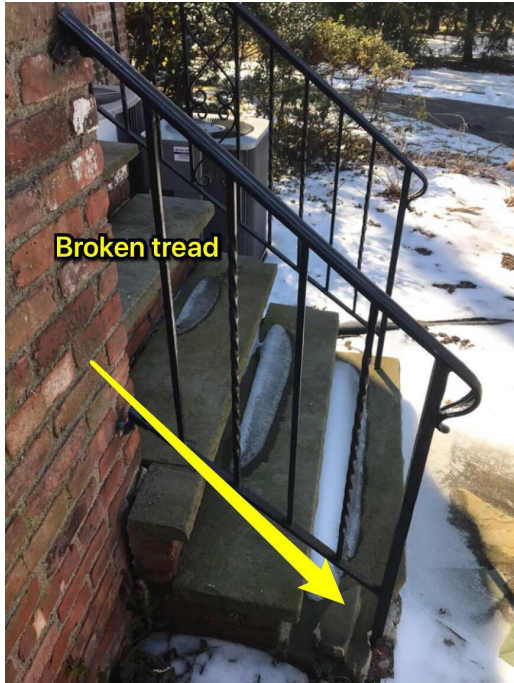
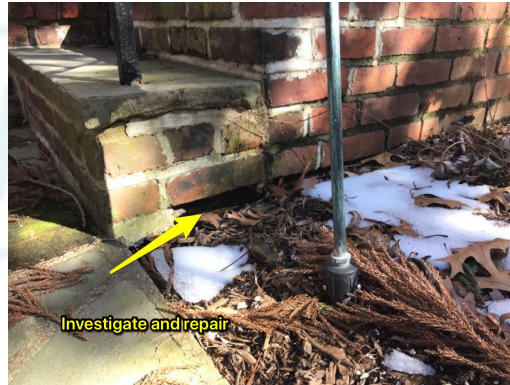
ATTN The lowest tread of the stairs at the entrance nearest to the driveway is cracked and deteriorated. We recommend it be repaired or replaced. The base of the stairs near the kitchen shows mortar deterioration. This should be further examined and repaired. This will help prevent water penetration and further damage.

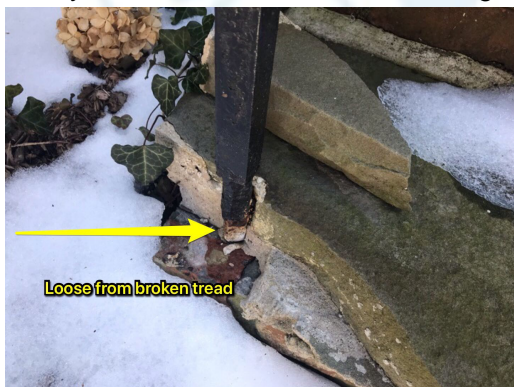
ATTN The railings at the entrance near the driveway, and going up from the garage to the patio are not sturdy. We recommend that the railings be reinforced or reset in accordance with present standards.

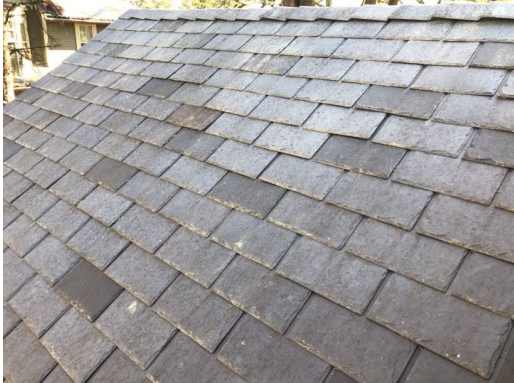
FYI **LIM** The roof on the main house is a single layer of EcoStar Rubber Shingles with a slate-like look, having a stated expected life of 50 years or more, according to the manufacturer. The roof surface appears to be in very good condition, and installed properly, with a combination of some steep and low slope areas. The visible flashings appear to be in good shape, as well as other roof penetrations such as vents.
NOTE: The roof was examined from the ground with Swarovski 8 x 30 binoculars, from upper windows where possible, as well as with a drone from above.

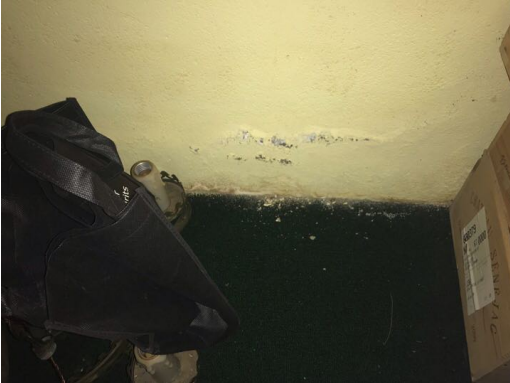
FYI There is a condition known as 'efflorescence' on portions of the foundation walls. This whitish, fuzzy material is a 'salt' deposit/ mineral deposit is left when moisture in the foundation evaporates on the inside of the foundation.

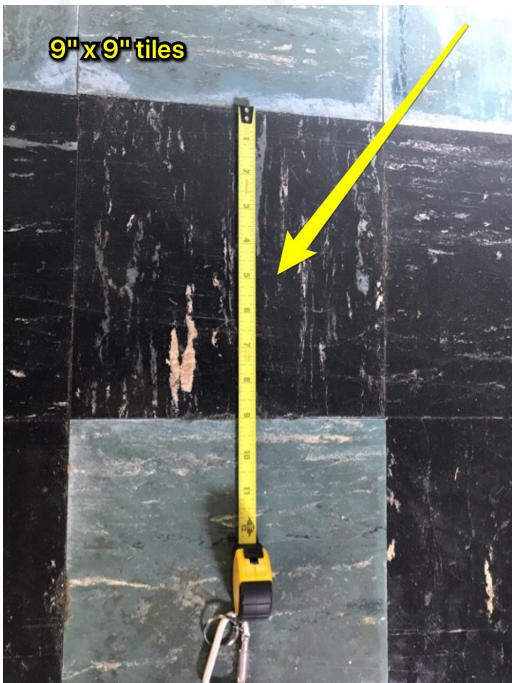
ATTN The tile floor covering, where visible in portions of the basement, is a type that frequently contains asbestos. Actual asbestos content can only be determined by laboratory testing. Further information on asbestos can be obtained from a licensed asbestos consultant or abatement contractor.

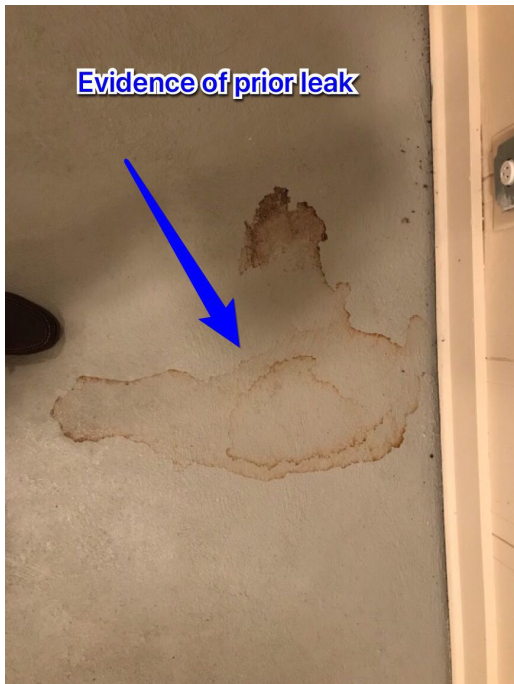
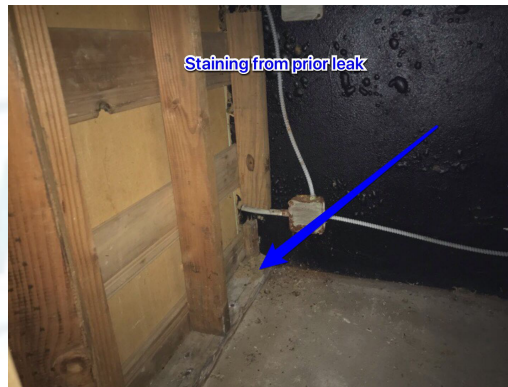
FYI The basement was dry at the time of this inspection. However, we direct your attention to the item mentioned below. NOTE: there was a stain on the "Studio" floor, indicating the presence of leaking water at some point, as well as staining on the lumber in contact with the floor in the crawl space under the Sauna Room window.

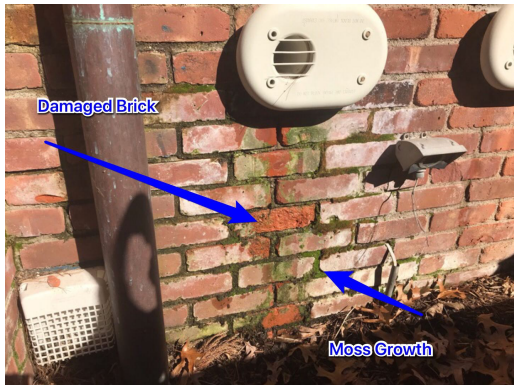
Dryer Vent

FYI While the dryer vent appears properly installed and in generally serviceable condition, condensed moisture accumulates and runs down the wall, causing degradation of the brick below and moss growth below.

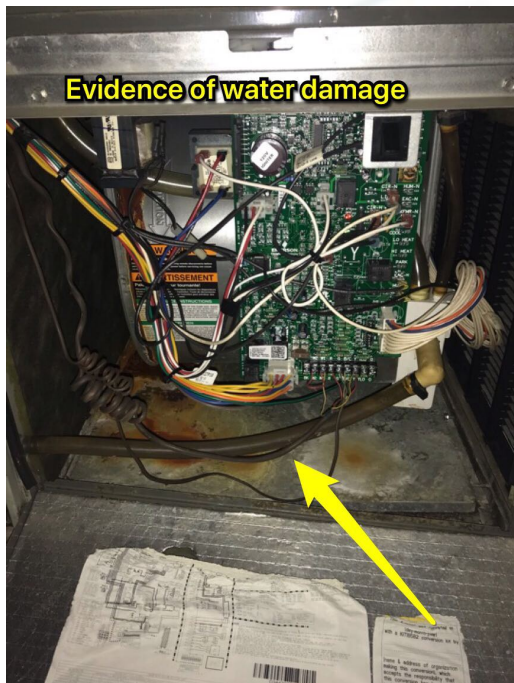
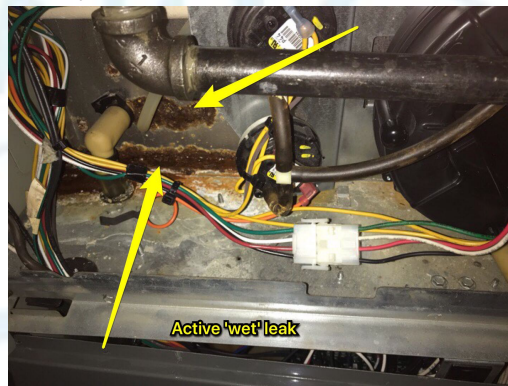
OK **URG** The two heating systems in the house both responded to normal operating controls. Components appear properly installed and are currently serviceable. Routine maintenance will keep them functional and maximize their service life. NOTE: The Trane XV90 model furnace showed signs of active water penetration. This should be further investigated by a professional HVAC technician.

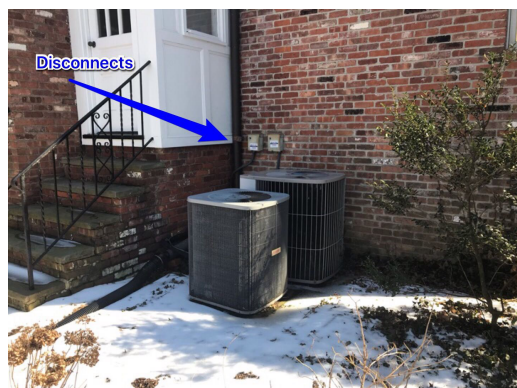
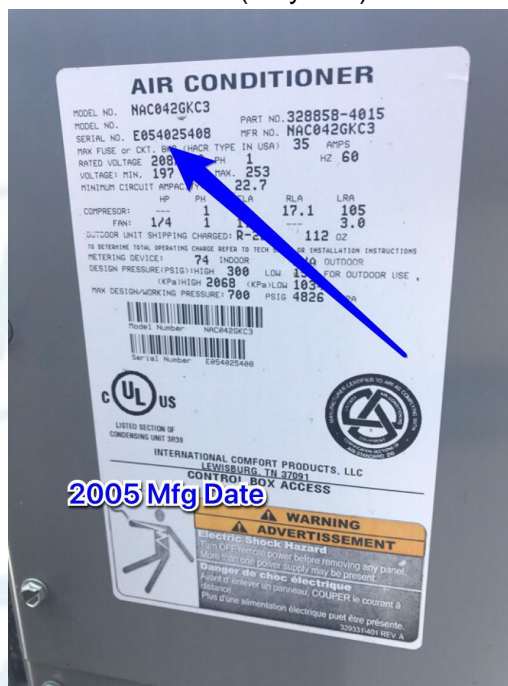
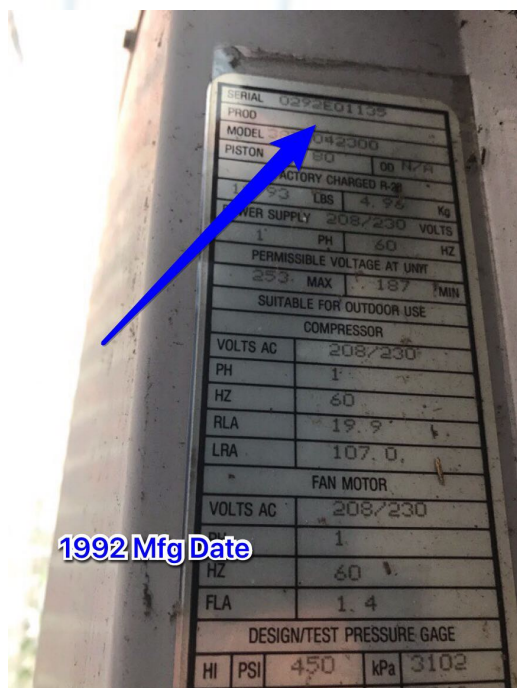
ARCOAIRE

Arcoaire: the serial number indicates a manufacture date of 2005 (14 years).

Carrier: the serial number indicates a 1992 manufacture date (27 years).

FYI **URG** The air conditioning compressors are older units - one is near the end of its normal expected service life, and the other appears to be well beyond it. These units can theoretically last 20 years by some estimates. Although as of last summer they may have been operating and in serviceable condition, the need for replacement should be expected within the next few years. NOTE: A/C systems have been known to provide service well beyond their anticipated life expectancy especially if they have been well maintained.

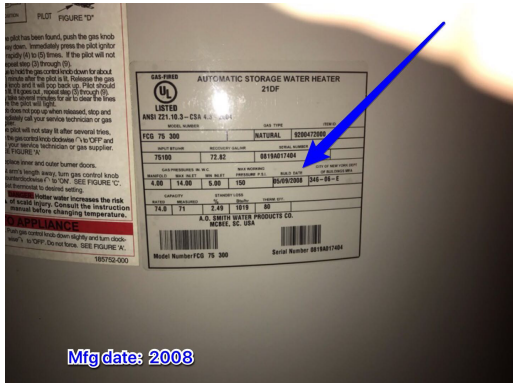
FYI Age: Estimated to be approximately 11 years old, as is visible on the data label. Water heaters can sometimes last well beyond the warranty period stated. However, the life expectancy varies greatly depending upon local water chemistry, system use, operating temperatures, and maintenance provided. Typically hot water heaters of this type have a life expectancy of 8-12 years but can last much longer. NOTE: Monitor for any leaks and replace when leaks occur.

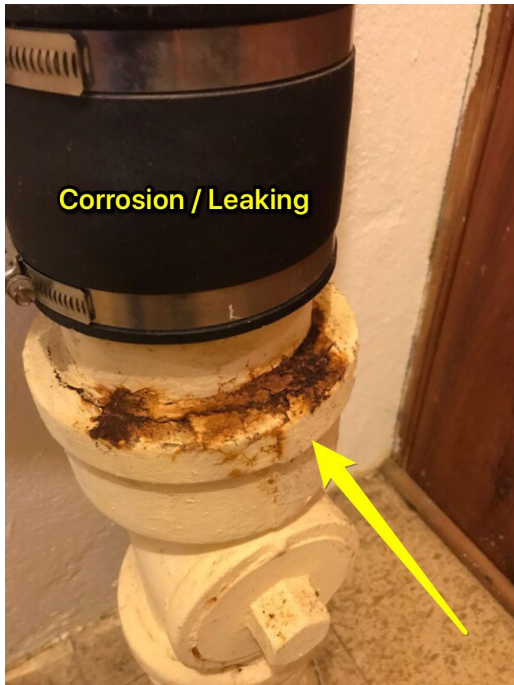
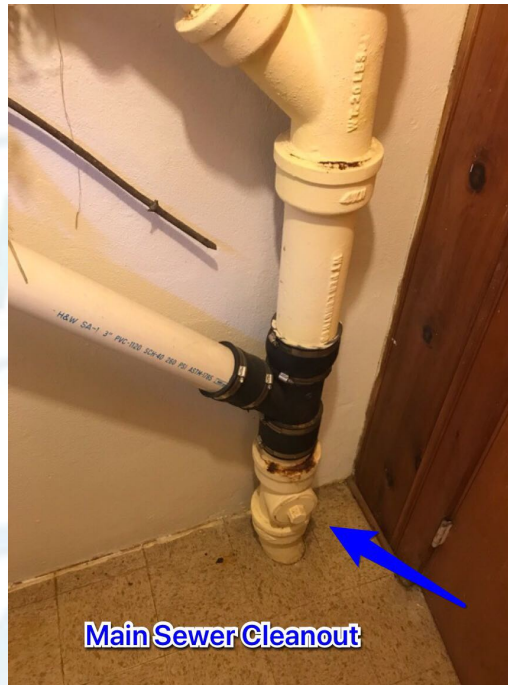
FYI **ATTN** The visible drain piping appears to be generally properly installed and in serviceable condition. We recommend a full camera review of the entire waste system. NOTE: There is evidence of corrosion of the cast iron drain line in the basement. Recommend further investigation by a licensed plumber.

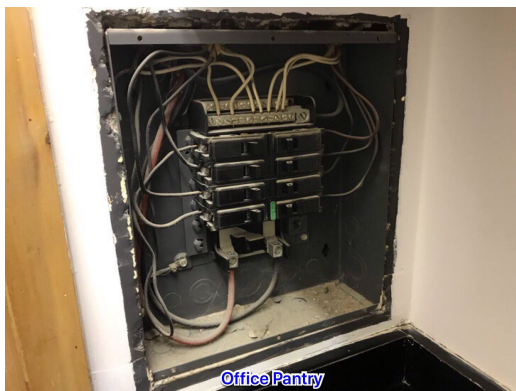
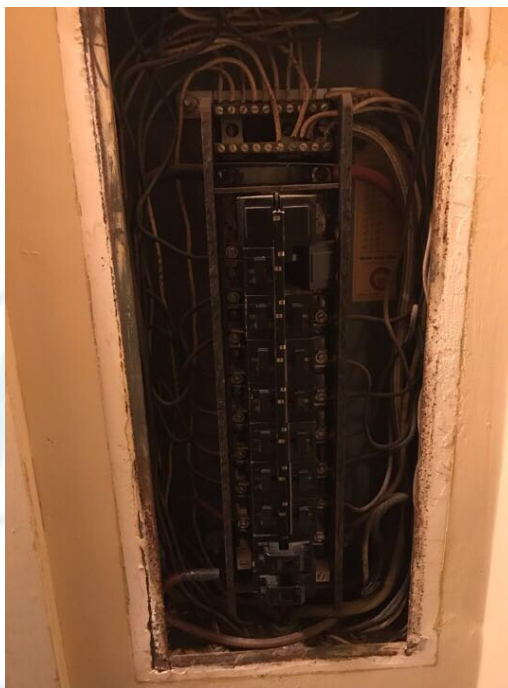
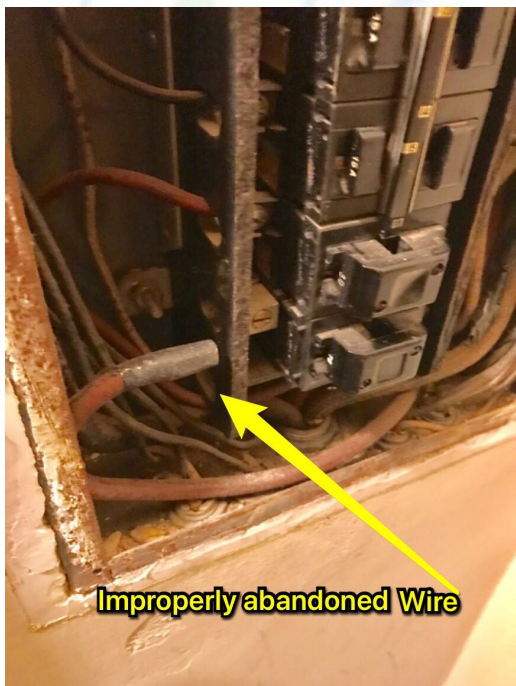
Main Hall Closet

FYI **ATTN** The subpanels were opened and the inspected circuitry was found to be installed and fused correctly. There appear to be improperly abandoned wires in the Hall Closet sub-panel. This should be further investigated by a NJ Licensed electrician.

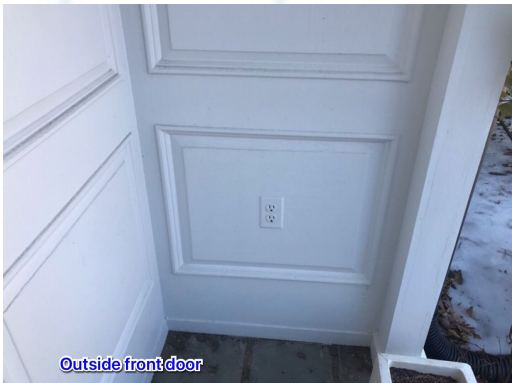
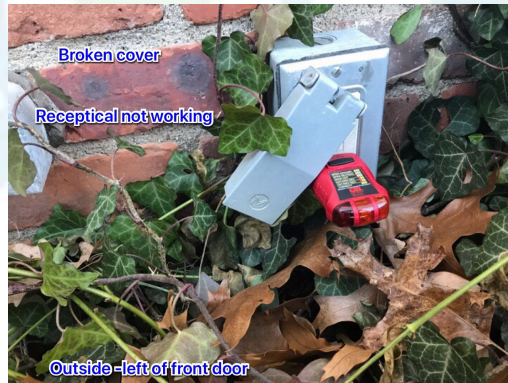
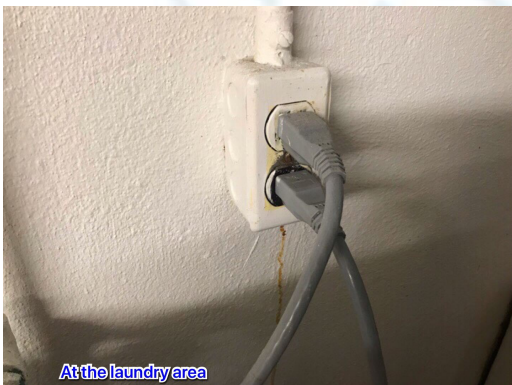
ATTN Incomplete GFCI protection is installed. We recommend upgrading by installing ground fault receptacles in all locations required by present standards. These include receptacles near sink basins, in bathrooms, garages, crawl spaces, and the exterior. Note: some exterior and interior examples are pictured below.

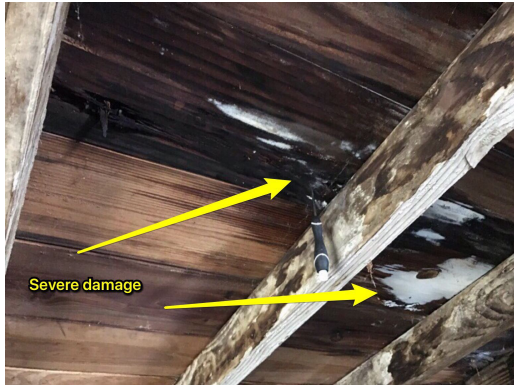
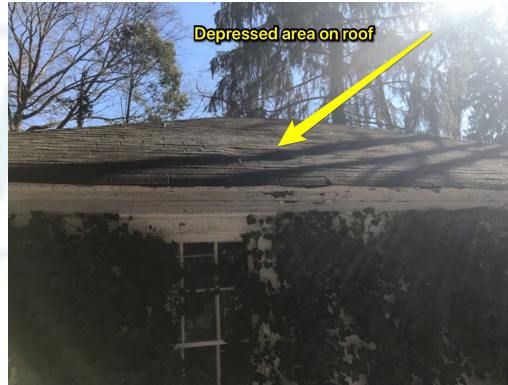
Detached Garage roof underside

NOTE: There is a second, detached garage on the property. The roof on this garage is seriously compromised, and must be replaced, including the under-sheathing and potentially any damaged structural support below. Additionally, there is a significant depression in the roof surface. We recommend repair or replacement by a NJ Licensed roofing contractor.

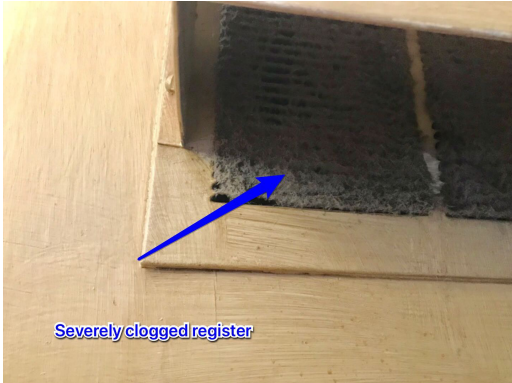
Family Room

FYI The hooded ventilation registers were severely clogged with dust and dirt. They should be cleaned to ensure proper ventilation flow.

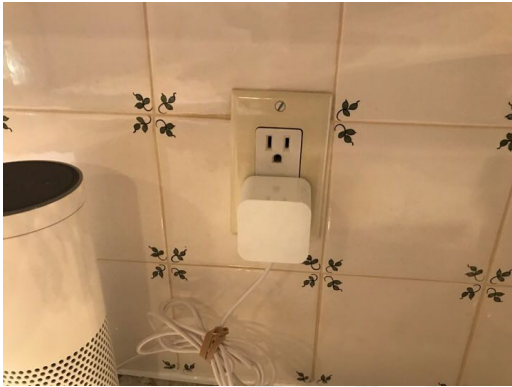
ATTN There is no GFCI (ground fault circuit interrupter) protection for the countertop receptacle(s) within six feet of the sink. For an increased margin of safety, we recommend the installation of a GFCI receptacle(s).

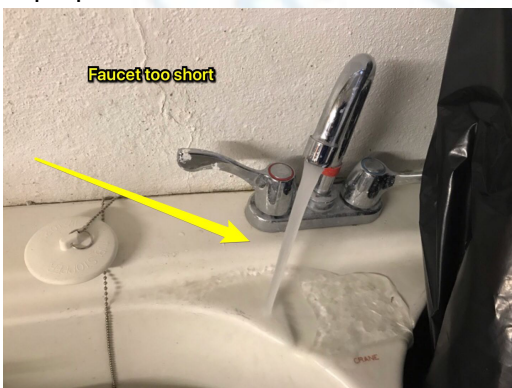
Laundry Area Sink

ATTN The faucet needs to be replaced with one that flows directly into the sinks. The current installation is improper.

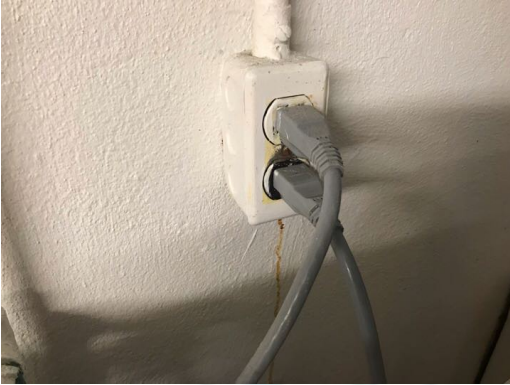
Utility Room

ATTN There is no GFCI (ground fault circuit interrupter) protection for this area. For an increased margin of safety, we recommend the installation of a GFCI receptacle.
