Confidential Inspection Report

LOCATED AT:
194 Pleasant Avenue
Bellview Heights, New Jersey 07101-2345

INSPECTED ON:
Wednesday, February 13, 2019

Inspector, John J. Hayes NJ 24GI 00172500
ClearView Home Inspections, L.L.C.

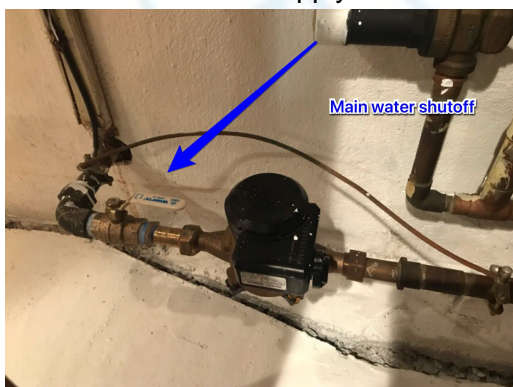
The domestic water supply main shut-off valve is located at the meter in the basement.

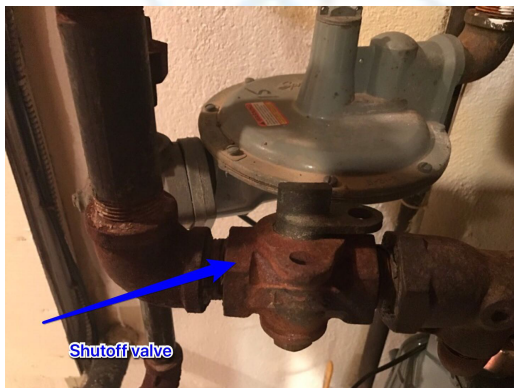
Gas Meter

The gas meter is in the basement. The main gas supply shutoff valve is located to the left of the meter, in front of the regulator. This valve should be turned 90 degrees (either way) in order to shut off the gas, should the need arise.

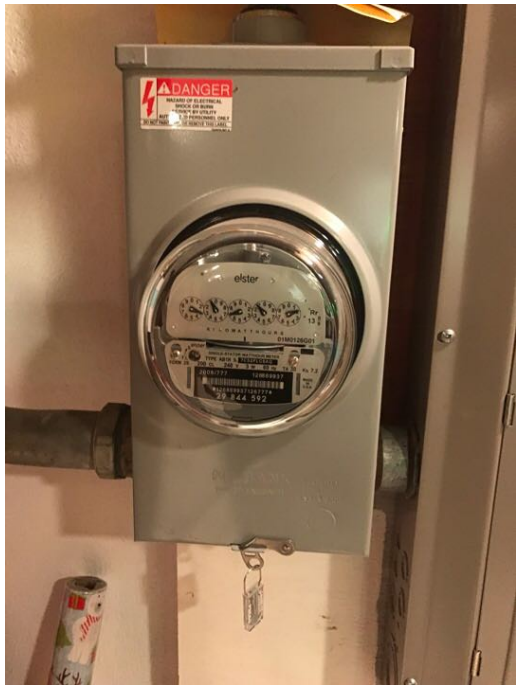
Ok the meter appears to be installed correctly and was operating and in serviceable condition.

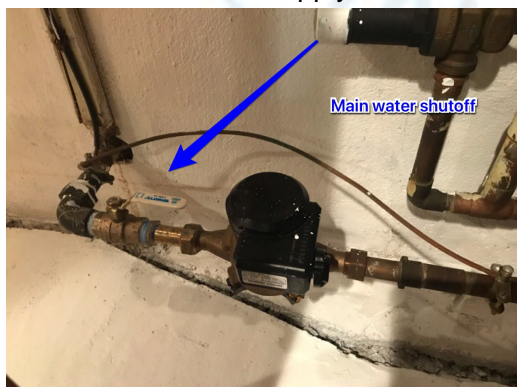
The domestic water supply main shut-off valve is located at the meter in the basement.

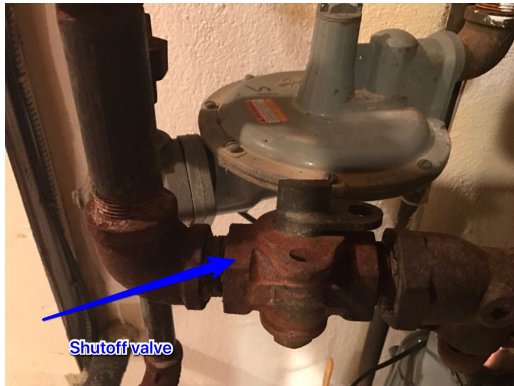
Gas Meter

The gas meter is in the basement. The main gas supply shutoff valve is located to the left of the meter, in front of the regulator. This valve should be turned 90 degrees (either way) in order to shut off the gas, should the need arise.
